**Phase 2 Geo-  
Environmental Site  
Investigation**

**Land at Clay Lane,  
Fishbourne**

**BRD3511-OR2-F**

**October 2022**

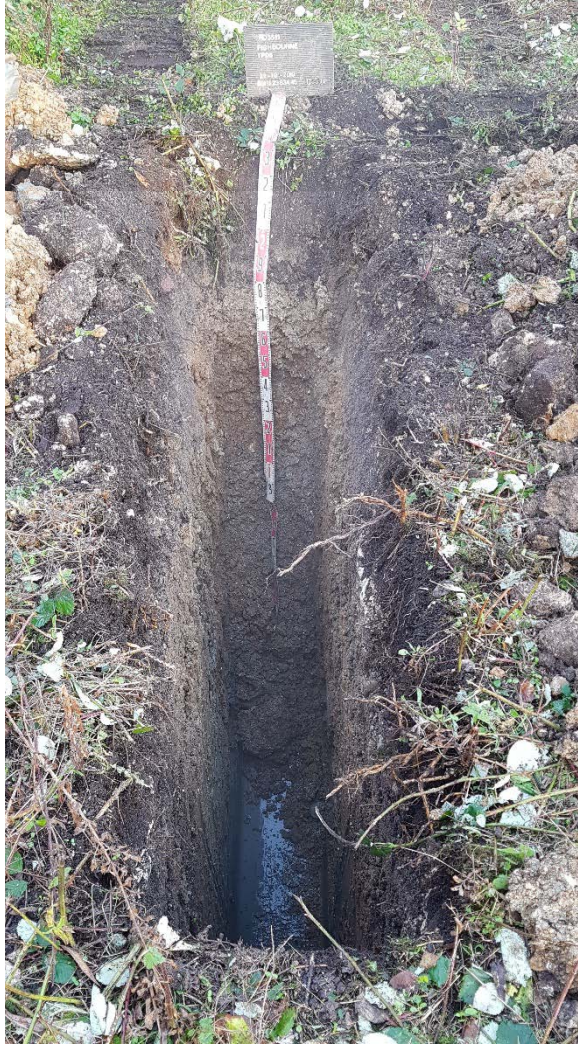
Trial pit TP06 (0.2m to 0.3m) and TP103 (GL to 0.1m) encountered a concrete slab overlying Made Ground which extended to depths of 0.4m bgl. No reinforcing bar was observed in the concrete. It is considered that these concrete slabs were base of the former barns located in this area.

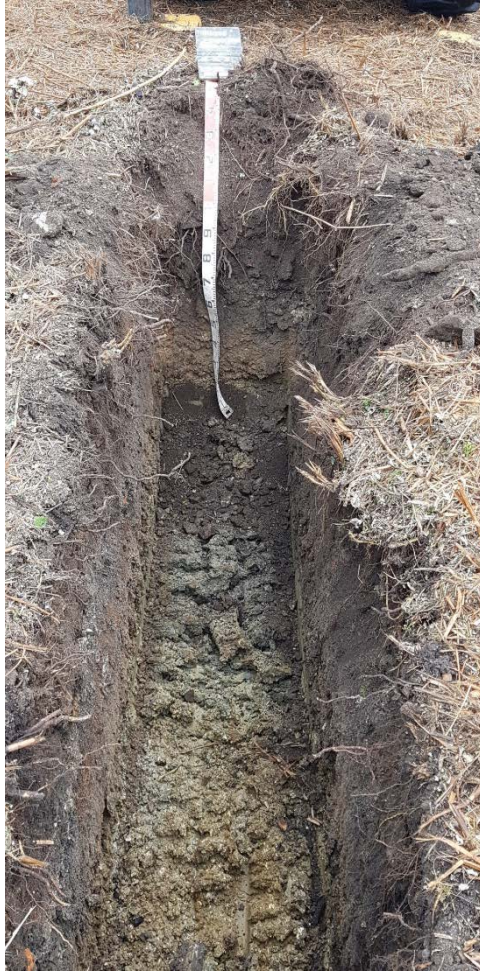
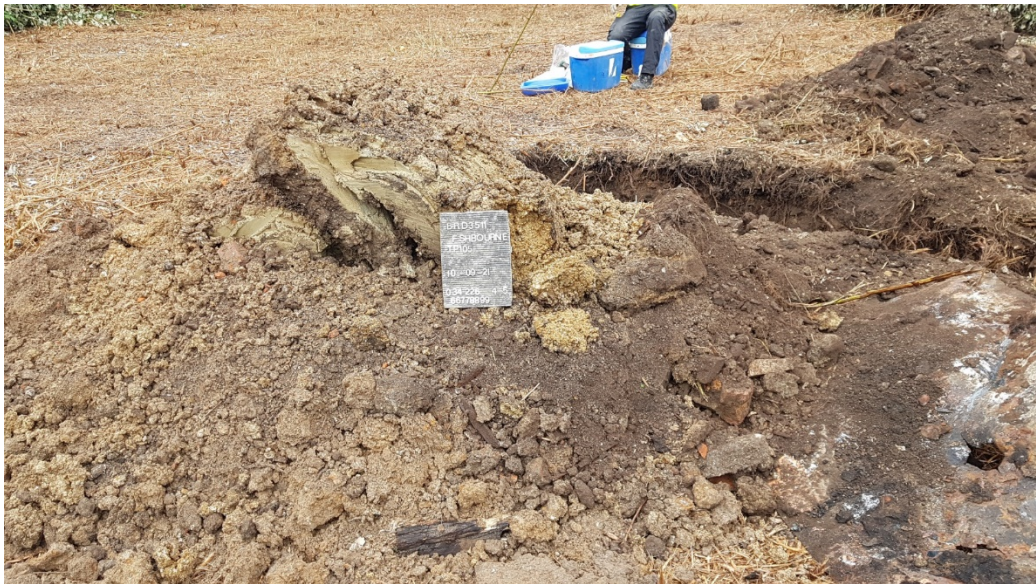
The Made Ground soils were proven to a maximum depth of 0.6m bgl with the soils mainly consisting of reworked topsoil with brick and metal fragments with occasional clinker. Of particular note was TP105 which contained 'Burnt metal, clinker and charcoal fragments'
